December 2015 * Mt.Tron University of Peace Foundation * No. 3-4 Vol. 18

What has happened at Tronsvangen Seter since the takeover this summer?

In this special double issue we look at the renovations, upgrades and investments carried out after the property had suffered from standing empty for four years and from many years of general neglect. We also look at visits and other activities during late summer, autumn and early winter, together with plans and possibilities for operation in 2016. Turn the page for our photo reportage and more!

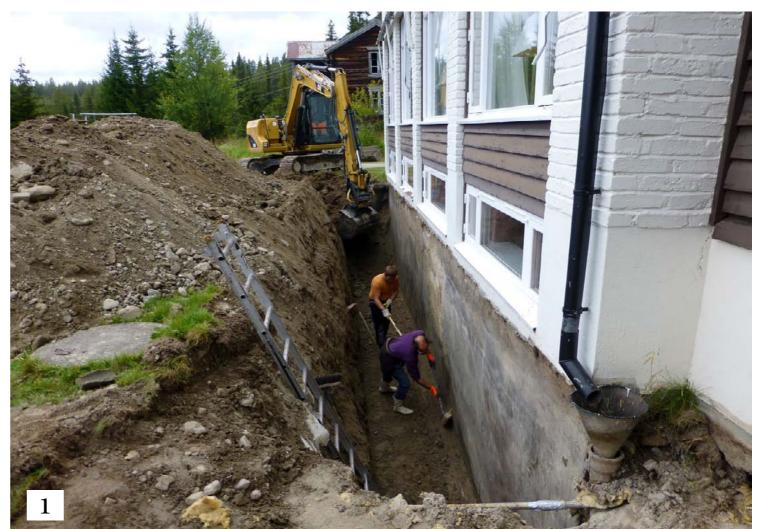
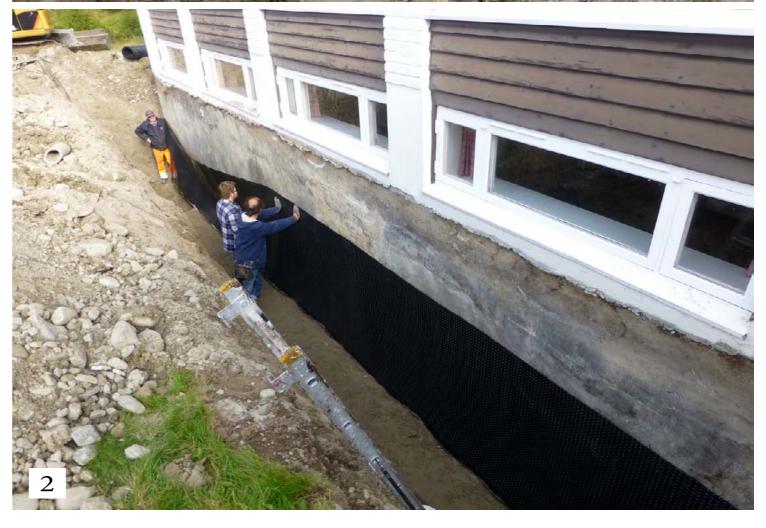
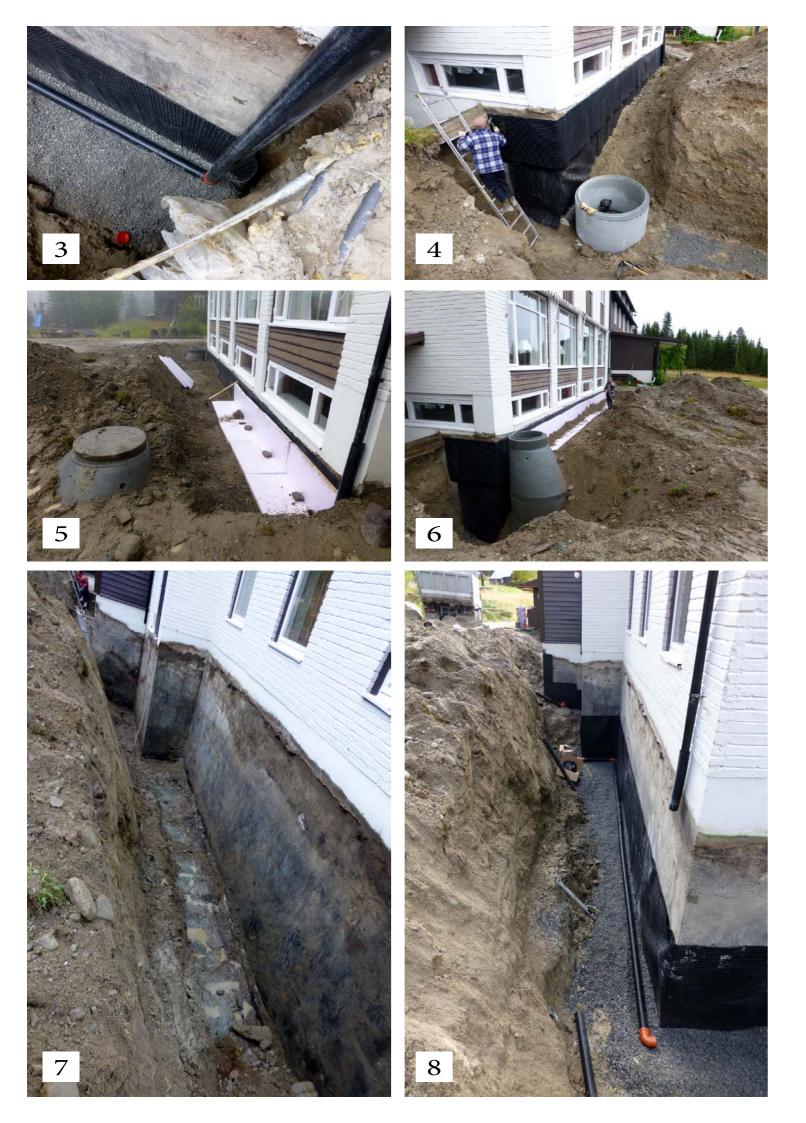
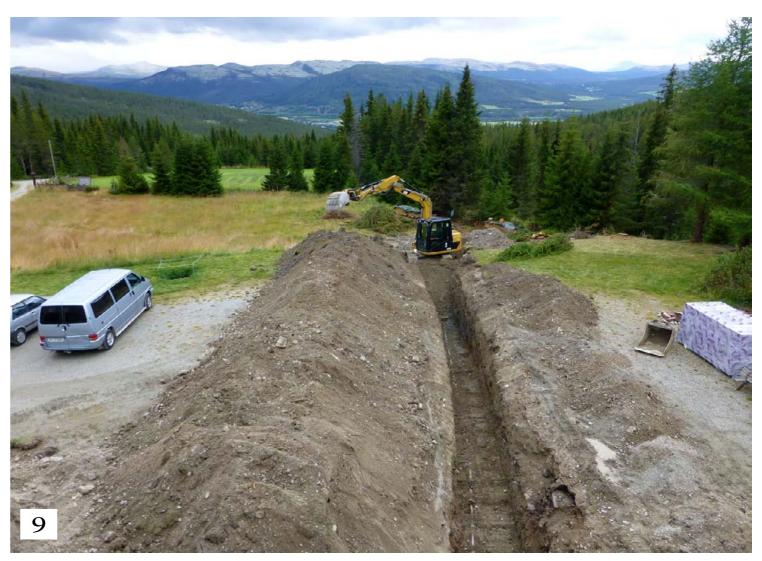
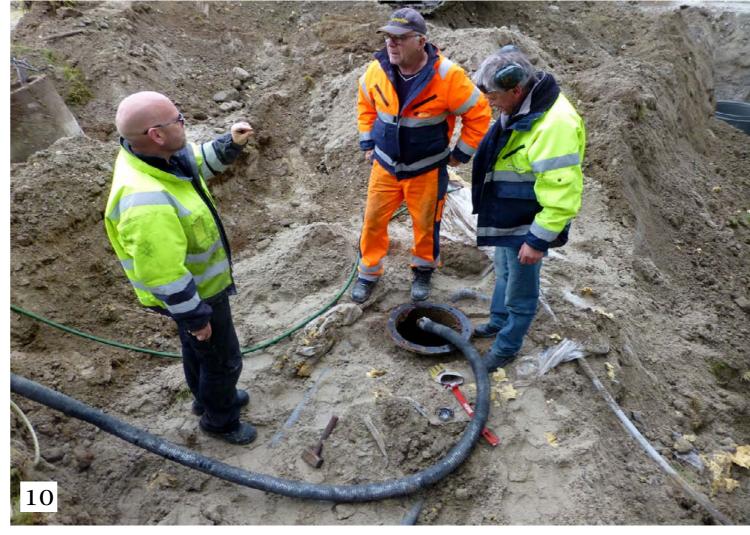
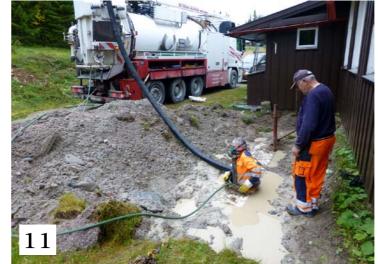
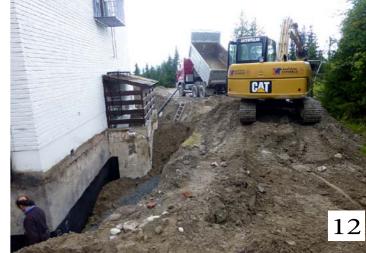
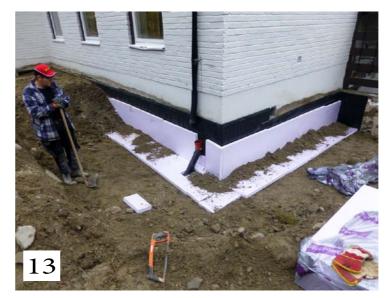
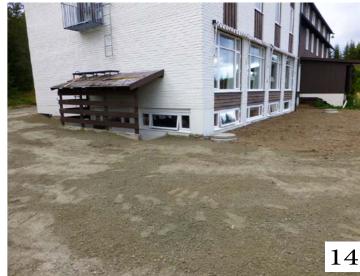
Digging with drainage and insulation

The digging started on September 15th and lasted for ten days, just as the digger, Juul Arne Sinnerud, had calculated beforehand. First the South-West side of the building was dug, exactly where the new part of the building (bricks) starts, just near the entrance, and down about 2.5 metres to the footing of the foundation wall, and forward to the end of the building (picture 1).

It was also dug on the other side of the building, from the kitchen entrance and all the way down to the end of the building (picture 7). And lastly the North-West end of the building was dug (picture 12).

A layer of crushed stone with a perforated drainage pipe on top, itself covered with a new layer of crushed stone was laid at the bottom of the ditch. After brushing the wall, a special kind of foundation wall millboard was nailed to the wall. First one breadth from the bottom (picture 2), and then another breadth above (picture 4). But before the second breadth of millboard was put in place, compact drainage pipes connected to the downpipes were laid down in the ditch (picture 3 and 8). These compact drainage pipes were also covered by a layer of crushed stone, and then the ditch was partly filled up with soil, after the second breadth of millboard had been nailed to the wall (picture 4).

After that insulation plates were put in place, first vertical into the wall, and then horizontal (perpendicular) to hinder frost from entering into the ground (picture 5 and 13).

A ditch for the outflow was dug from a bowl in the North-West corner of the building across the slopes to the neighbouring land (picture 9). A bigger bowl now replaces the old one which was considerably smaller (picture 4 and 6).

While the digging was going on at the front, the vacuum toilet system inside the building became blocked. Ivar Lien from Nord-Østerdal Mijøservice AS had to be called and plumber Terje Dalsegg and Juul Arne and we all had a hard time getting it clear again (picture 10).

At the rear of the building, near the kitchen entrance, it became necessary to dig up an old oil tank before the digging of the ditch could start. Again Ivar Lien had to be called, this time for the emptying and degassing of the tank before digging it up (picture 11). The tank was already entirely empty of oil.

Also at the rear the main water pipe comes into the building together with the electrical earth cable. The local power company had already marked the position of the earth cable but we had no clue as to where the water pipe entered the building. Therefore the first day of digging outside at the back became rather tense but it all turned out fine. On this side of the building the ground was more clayey and very wet. At certain places we even found water in the ditch (picture 7)! This left us with no doubt about the necessity of doing this digging, something which had been clear to us before from looking at the condition of the basement walls inside.

When the digging of the ditches was finished, they were filled up and closed, then levelled at the surface and lastly a few truck loads of very finely grained crushed stone were laid out on top all around the building where the digging work had been going on. An overgrown ditch towards the forest before the open space into the building, was dug up and restored (pictures 14 and 15).

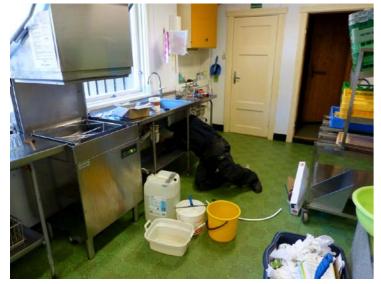
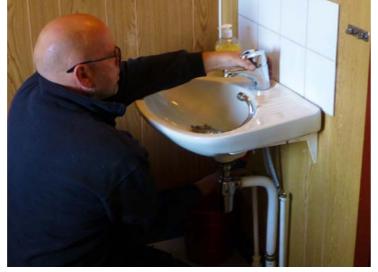
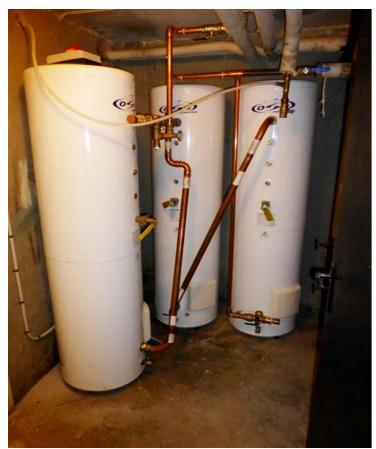
Other craftsman's work and installations

Above: Plumber Terje Dalsegg has virtually been living at Setra since we took it over this summer: He started with the installation of a 200 litre water heater, as we didn't dare to start up the existing old ones. Then he changed six old vacuum toilets which were broken, perhaps by frost, and thereafter washbasin fittings in almost all the rooms, together with the kitchen. Otherwise he has changed and replaced all horizontal outlet pipes belonging to the vacuum system in the basement, relating to the old part of the building, which were all about 30-50 % blocked by petrified sedimentation. In one place there was a plug which covered about 75 % of the pipe's opening, and which had caused problems during most of autumn. This plug may have been several years old.

To the left: The newest (01.12.) plumbing work; the installation of three 400 litre water heaters with an economical mixing valve, which will be serving all the rooms with hot water. From now on the first 200 litres will serve the kitchen only.

Below: Alvdal Blikkenslagerverksted AS (tinsmith) by Ivar Oddlien and assistant, changed the most pressing of broken gutters and downpipes, during some days at the end of September.
